**Flood Control Project Maintenance
Levee Inspections
LMA District Cover Sheet
Spring 2010 Levee Inspection Results**

Knights Landing Ridge Drainage District

Spring 2010 Levee Inspection Results

Waterway			Bank	Unit Miles
Unit No. 01 Knights Landing Ridge Cut			Right	6.43
	Spring (March - May)	Summer (June - August)	(September - November) Fall	Winter (December - February)
Unit Maintenance Rating (Fall Only)				
Date of Inspection	4/6/2010 - 4/6/2010			
DWR Inspector	John Williamson			
Accompanied By	Chad Navarrot RD 108

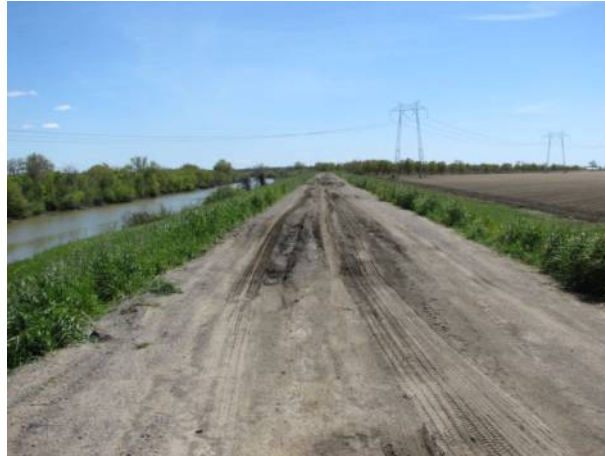
Levee Mile Report Line	4
Start Levee Mile	0.23
End Levee Mile	1.59
Location	Crown
Category	Earthen Levee
Item	Crown Surface / Depressions / Rutting
ruts 6" are deeper	
johngw_s_20100406_110.jpg

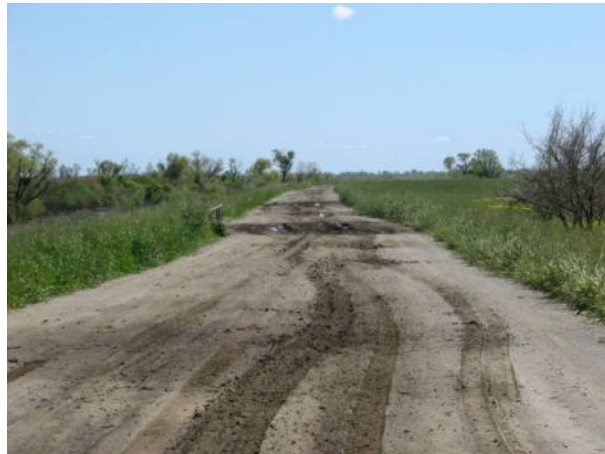
Levee Mile Report Line	4
Start Levee Mile	0.23
End Levee Mile	1.59
Location	Crown
Category	Earthen Levee
Item	Crown Surface / Depressions / Rutting
additional spots ruts 6" or deeper	
johngw_s_20100406_111.jpg

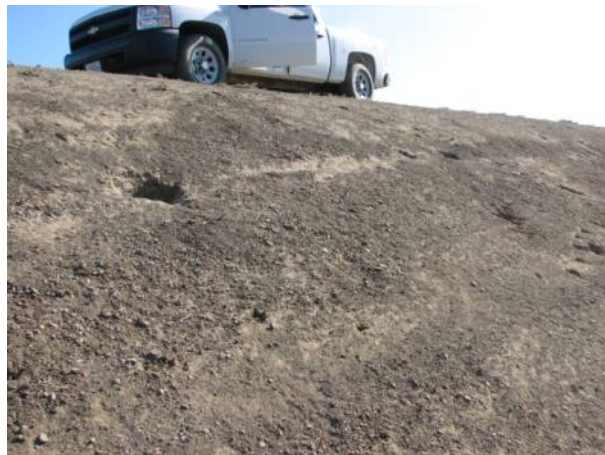
Levee Mile Report Line	5
Start Levee Mile	0.69
End Levee Mile	0.69
Location	Land Side
Category	Earthen Levee
Item	Animal Control
squirrel holes landside	
johngw_s_20100316_018.jpg

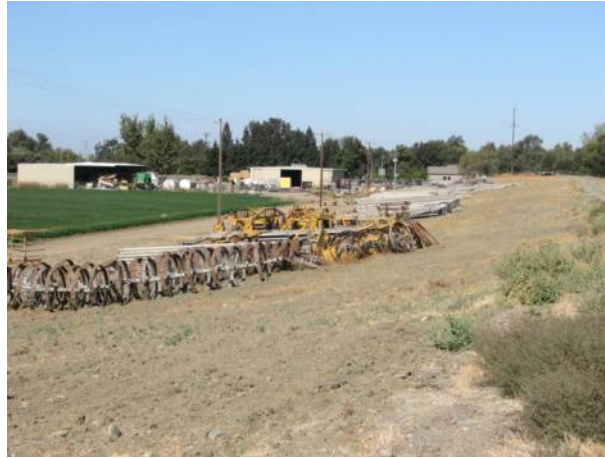
johngw_s_20100316_017.jpg

Levee Mile Report Line	13
Start Levee Mile	6.17
End Levee Mile	6.41
Location	Land Side
Category	Earthen Levee
Item	Encroachments

equipment on levee slope

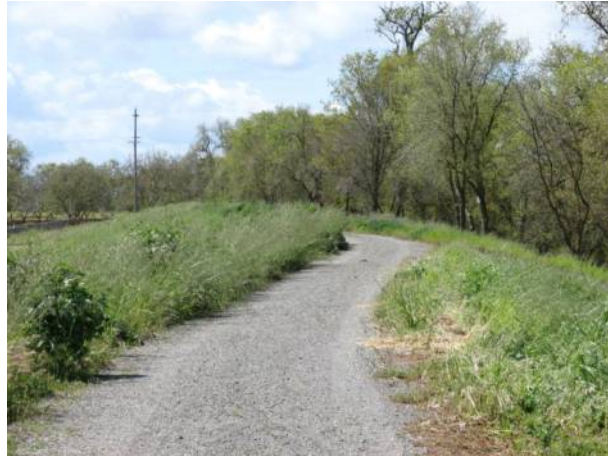
Levee Mile Report Line	1
Start Levee Mile	
End Levee Mile	
Location	Land Side
Category	Earthen Levee
Item	Vegetation
vegetation taller than 12"	
johngw_s_20100405_102.jpg

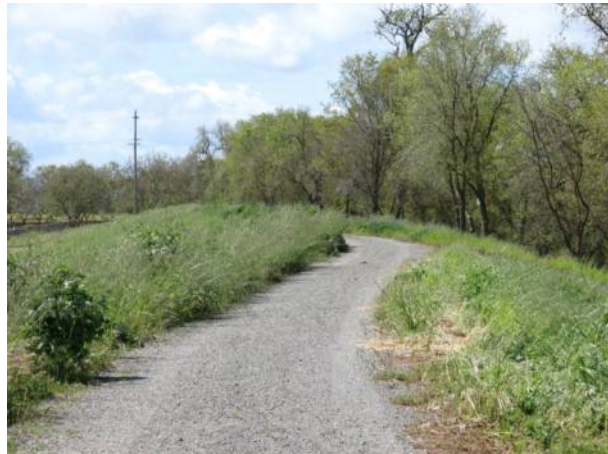
Levee Mile Report Line	2
Start Levee Mile	
End Levee Mile	
Location	Water Side
Category	Earthen Levee
Item	Vegetation
Vegetation taller than 12"	
johngw_s_20100405_101.jpg

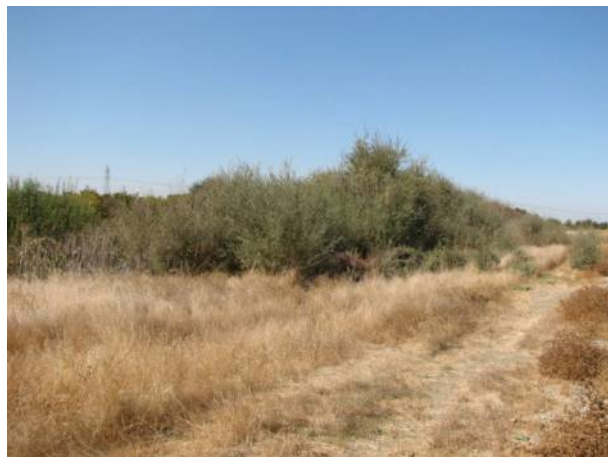
Levee Mile Report Line	3
Start Levee Mile	0.69
End Levee Mile	0.75
Location	Water Side
Category	Earthen Levee
Item	Vegetation
remove willows	
johngw_s_20100316_020.jpg

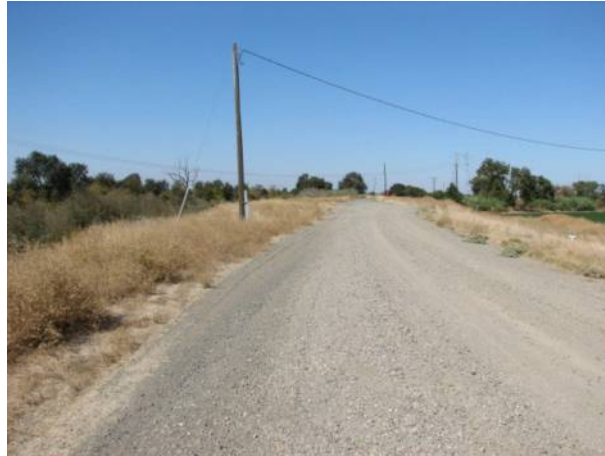
johngw_s_20100316_022.jpg

Levee Mile Report Line	4
Start Levee Mile	0.81
End Levee Mile	0.99
Location	Water Side
Category	Earthen Levee
Item	Vegetation

weeds taller than 12" need to mow

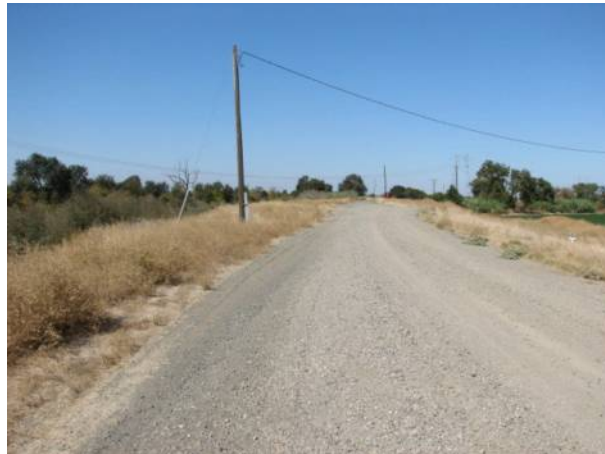
johngw_s_20100316_021.jpg

Levee Mile Report Line	5
Start Levee Mile	0.81
End Levee Mile	0.99
Location	Land Side
Category	Earthen Levee
Item	Vegetation

same for landside

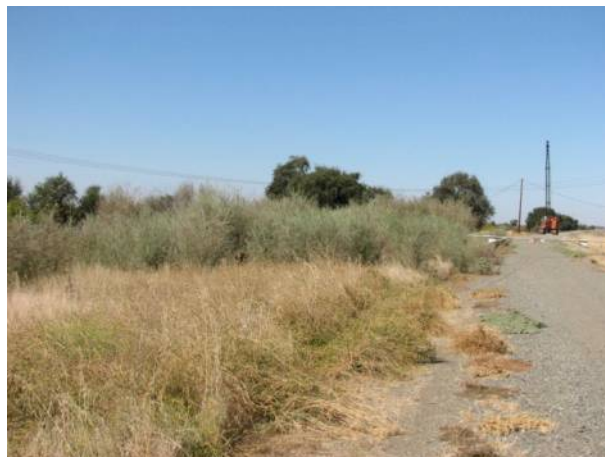
johngw_s_20100316_019.jpg

Levee Mile Report Line	7
Start Levee Mile	0.95
End Levee Mile	0.95
Location	Water Side
Category	Earthen Levee
Item	Vegetation

remove and spray willows
